Report NO. ARAIB/AIR-F0801

Aircraft Serious Incident Report

Runway excursion during landing

A340-300

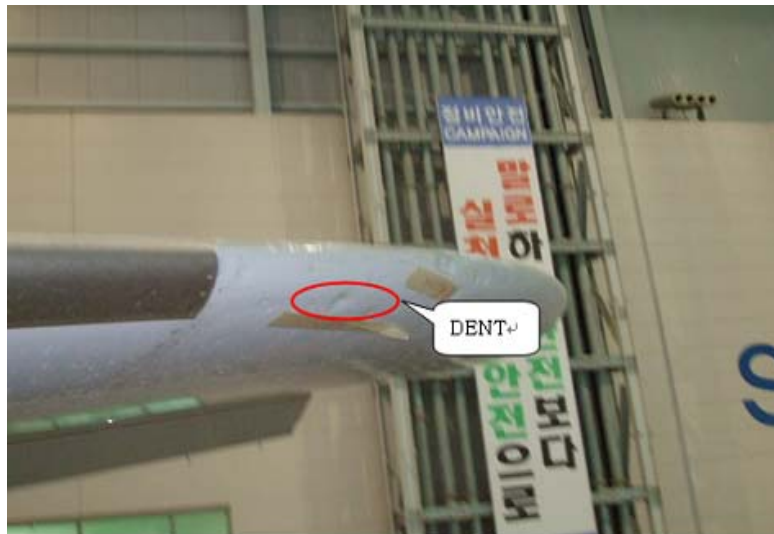
As shown in Photos 4 and 5 below, the left horizontal stabilizer tip portion was dented in many places and the front side was punctured.

[Photo 4] Damage to horizontal stabilizer 1

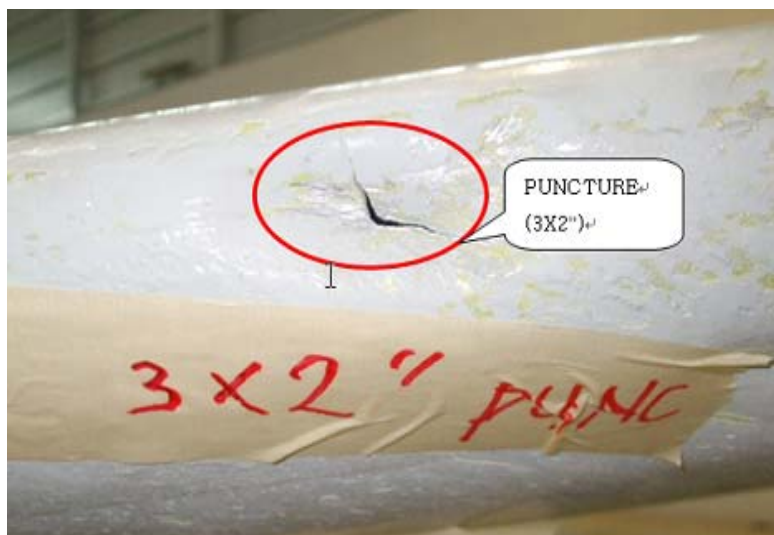
[Photo 5] Damage to horizontal stabilizer 2

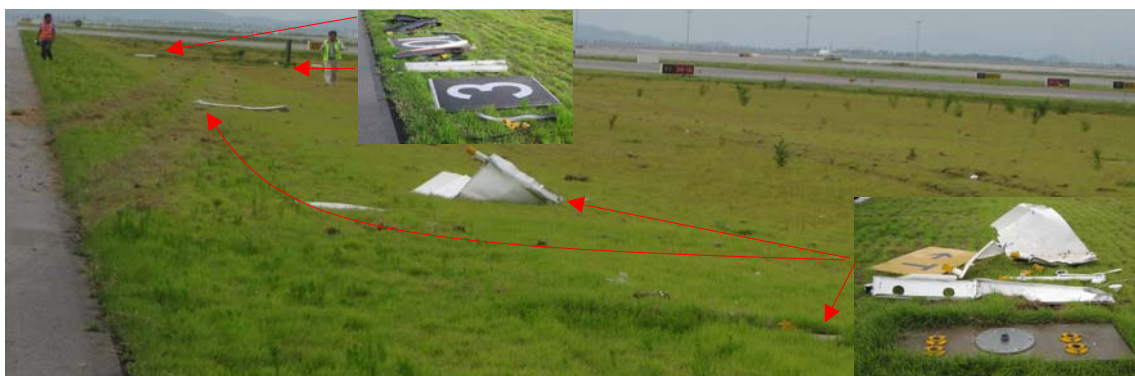
Two taxiway lights⁹⁾ located on both sides of Taxiway "T", one taxiway guidance sign¹⁰⁾, and one "10/3" runway distance marker sign¹¹⁾ were broken by contact with the landing gear and airframe of Flight 160 as shown in Photo 7 and Photo 8.

[Photo 8] Runway distance marker sign damaged

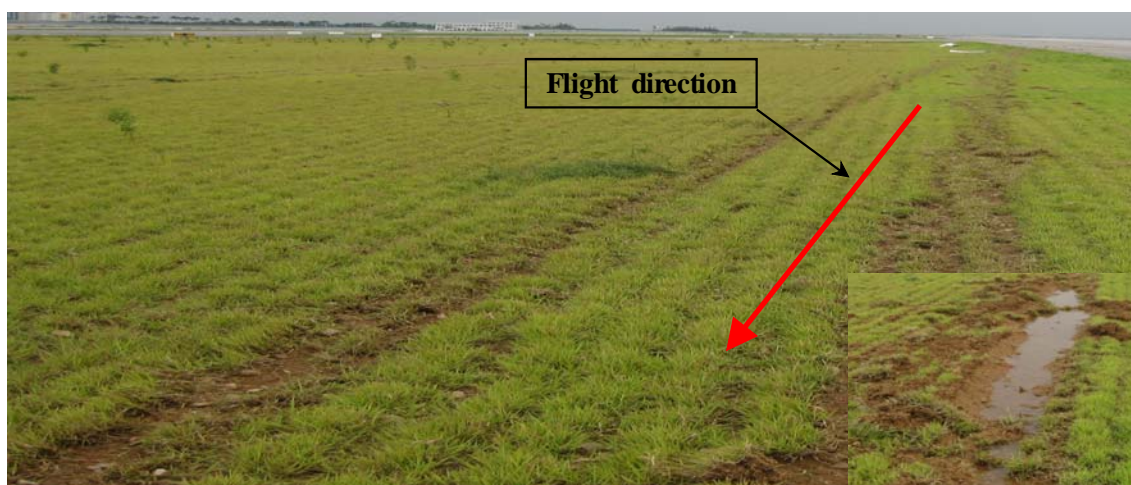
The landing strip between taxiways "T" and "N2" was damaged by the landing gear of Flight 160, about 400 meters long, 18 centimeters deep at most, and 80 centimeters wide at most as shown in Photo 9.

[Photo 9] Landing strip damaged

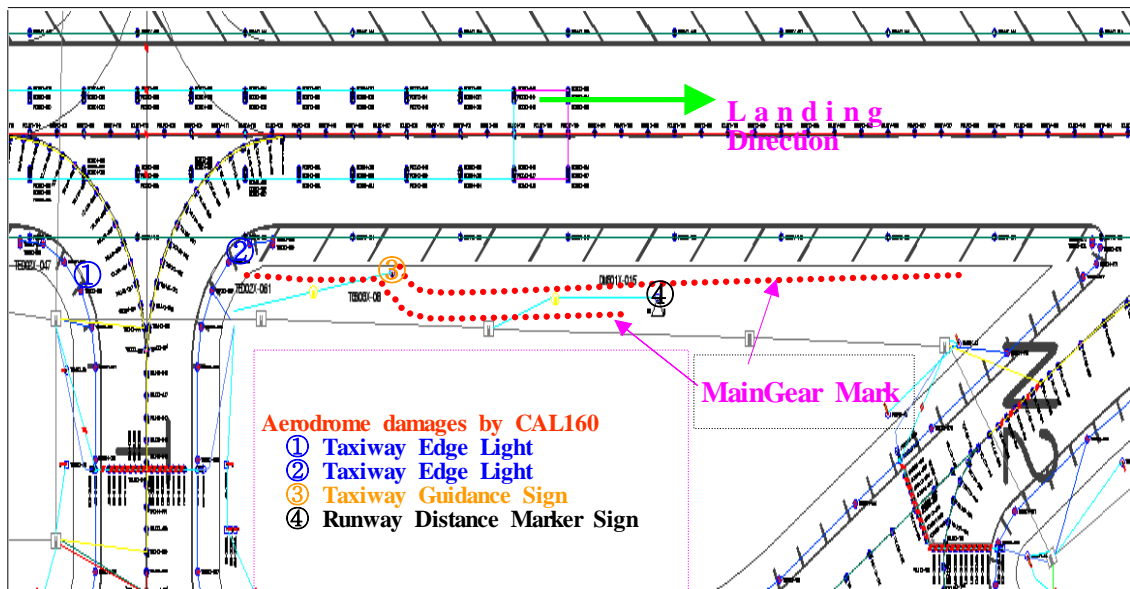
[Fig. 13] Situation map of runway excursion

According to the records of the ASDE (Airport Surface Detection Equipment) and the results of investigation of the trace, the circumstances of runway excursion as shown roughly in Figure 13.
