Report NO. ARAIB/AIR-F0801

Aircraft Serious Incident Report

Runway excursion during landing

A340-300

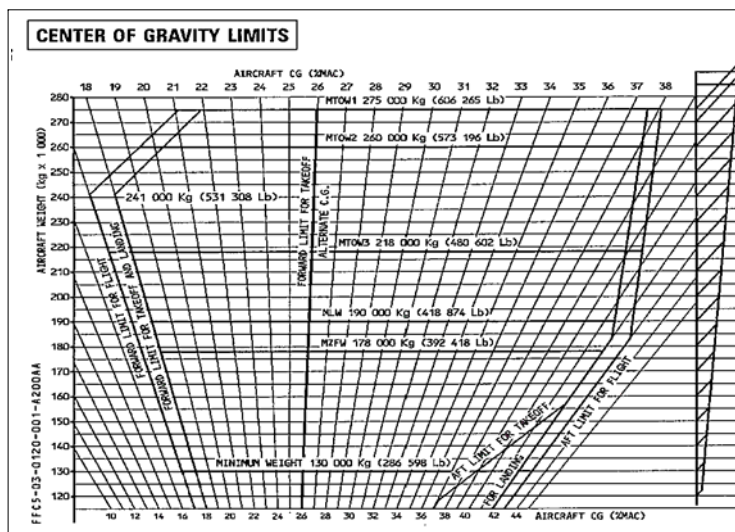
[Table 1] Weight and balance data

According to this Table, the take-off weight was 218,522 kg (401,824 pounds), zero-fuel weight was 164,484 kg(362,624 pounds), and the center of gravity of aircraft during takeoff was 33.6% MAC (Mean Aerodynamic Chord) and the center of gravity of zero-fuel weight was 34.5% MAC.

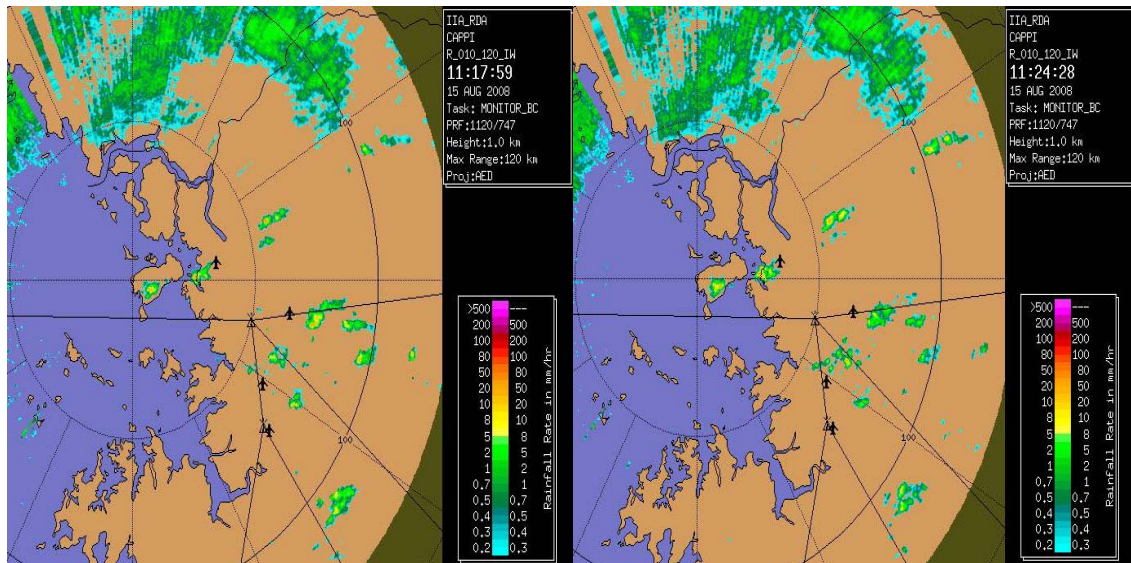
The precipitation ratio images observed by the TDWR around the time when Flight 160 was approaching to land on the Incheon Airport runway were as shown in Figures 1, 2, 3 and 4. According to these, small banks of cloud containing precipitation of 20 mm or more per hour were passing the south end of Incheon Airport from west to east.

[Fig. 1] Precipitation image at 11:17:59

[Fig. 2] Precipitation image at 11:24:28

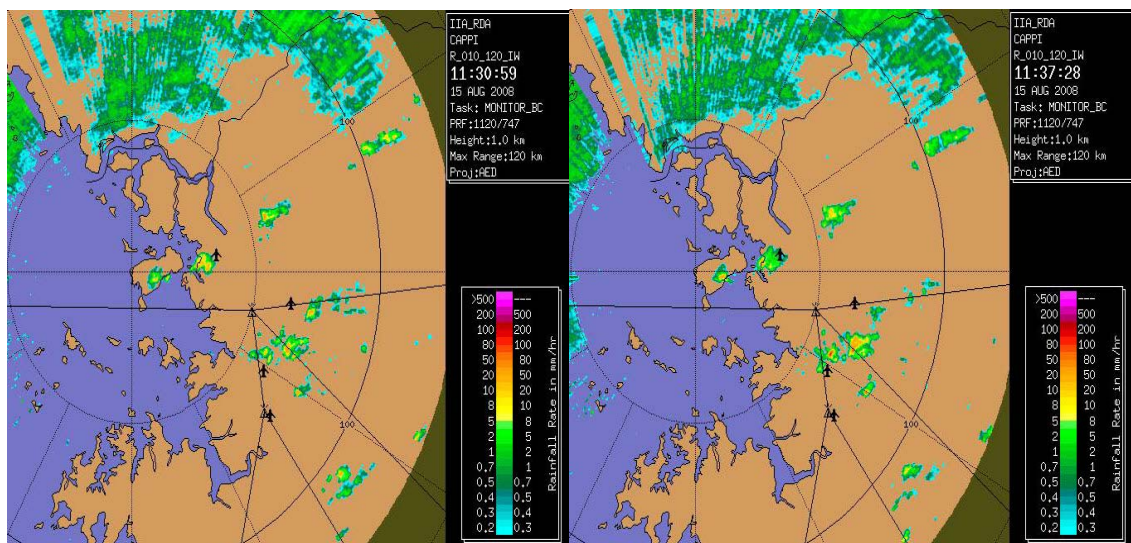
[Fig. 3] Precipitation image at 11:30:59

[Fig. 4] Precipitation image at 11:37:28

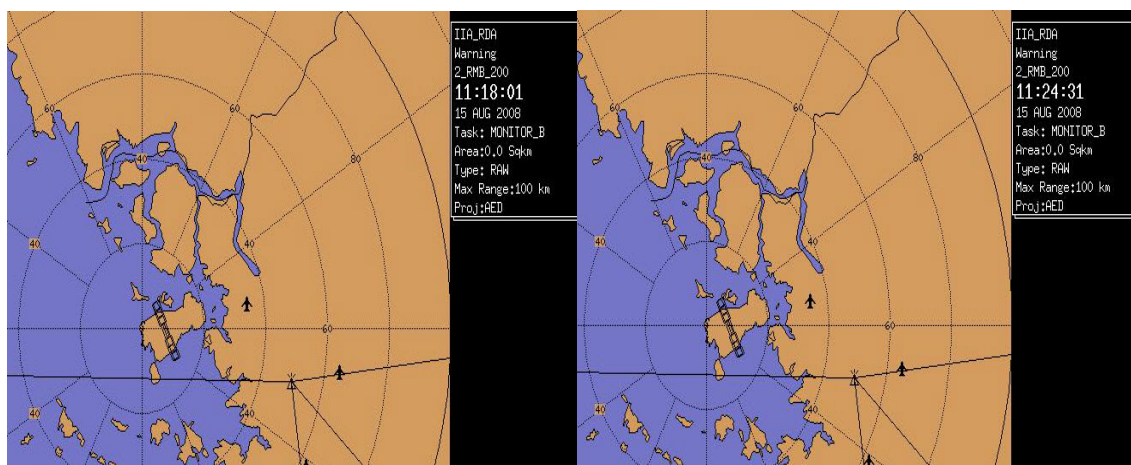
The images of the microburst detector (TDWR) at the time when Flight 160 was approaching runway 34 are shown in Figures 5 and 6, and the microburst was not detected according to these image data.

[Fig. 5] Microburst Detector image at 11:18:01

[Fig. 6] Microburst Detector image at 11:24:31

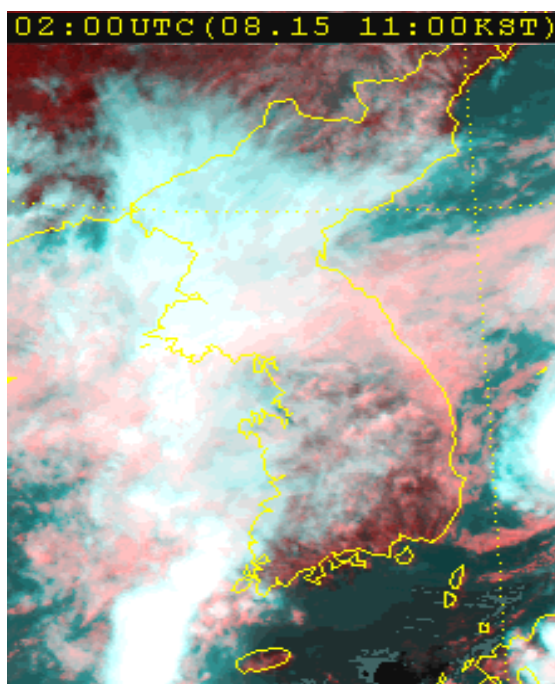
The distribution of clouds as observed by the weather satellite at the time when Flight 160 was approaching was laid lengthily north to south along the west coast of the Korean peninsula as shown in Figures 7 and 8.

[Fig. 7] Cloud distribution image at 11:00

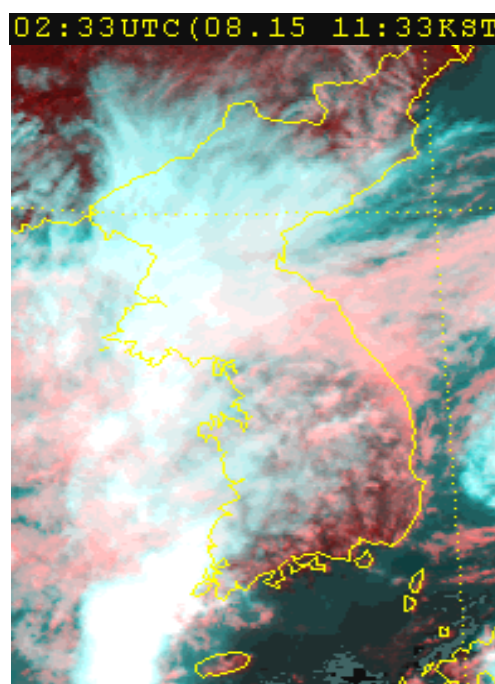
[Fig. 8] Cloud distribution image at 11:33

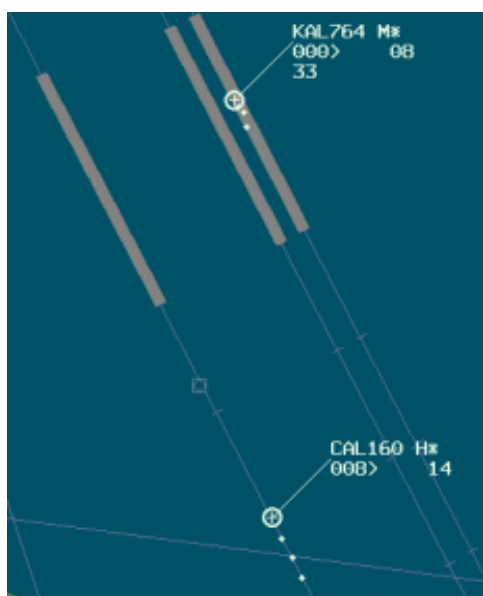
According to the recordings of the airport surveillance radar, the lateral deviation situations from the extended centerline of runway 34 until immediately before touchdown of Flight 160 are as shown in Figures 9 to 12.

[Fig. 9] Position at 800 feet

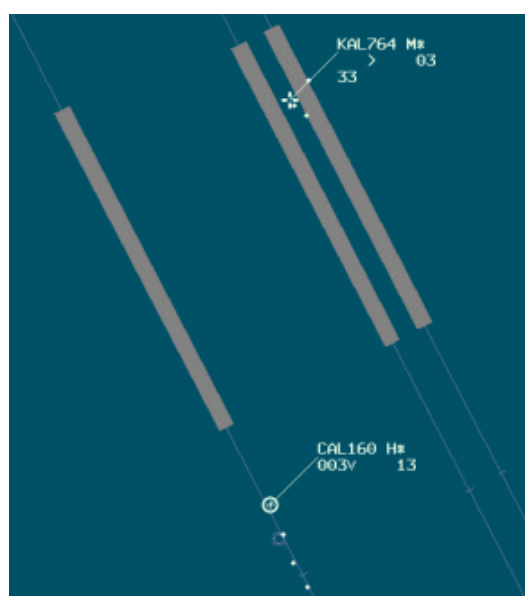
[Fig. 10] Position at 300 feet

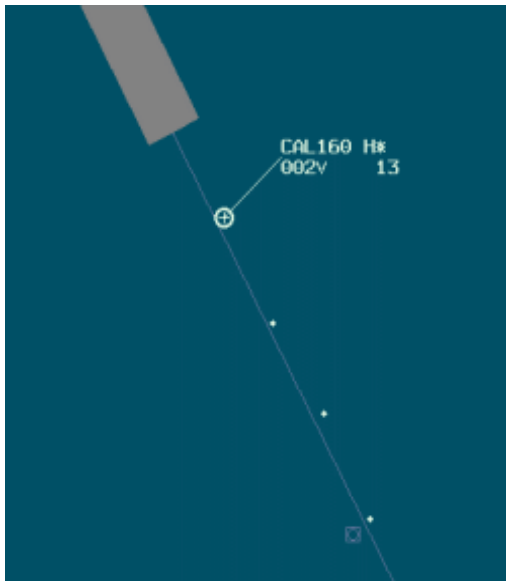
[Fig. 11] Position at 200 feet

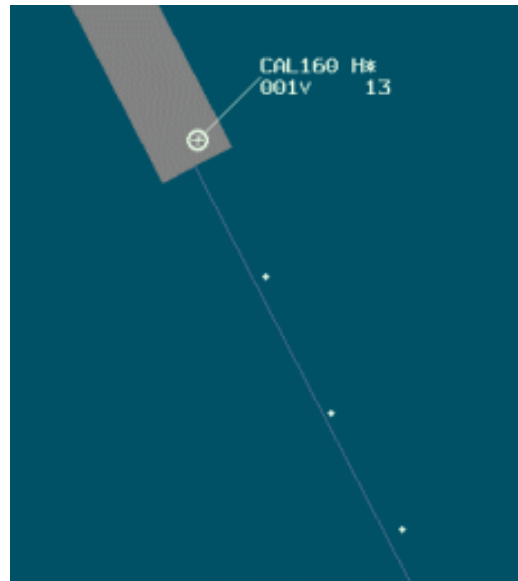
[Fig. 12] Position at 100 feet
