Content

- Statistics
- Most common causes
- Factors affecting the margins
- Aircraft design features
- Operational recommendations
- Conclusions

Avoiding Tail Strike

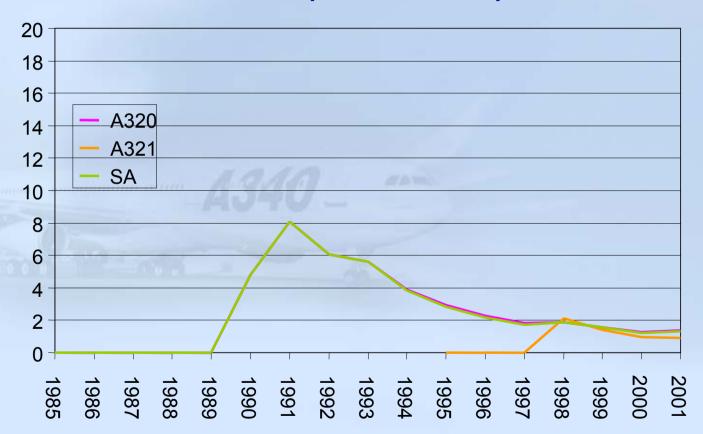
>> Statistics

Events at T/O per million of departures

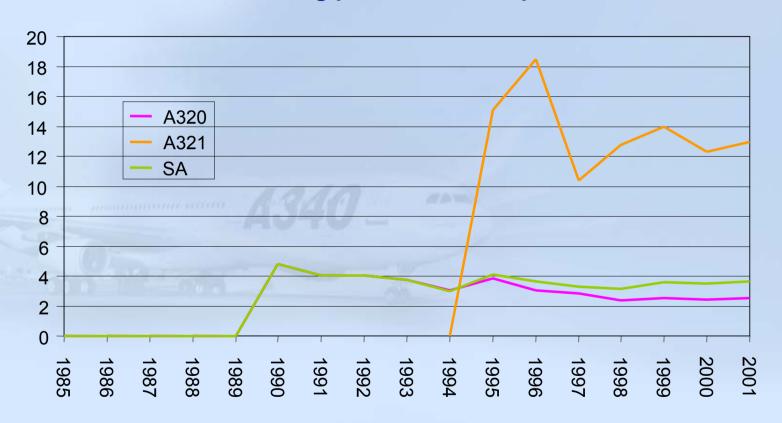
>> Statistics

Events at landing per million of departures

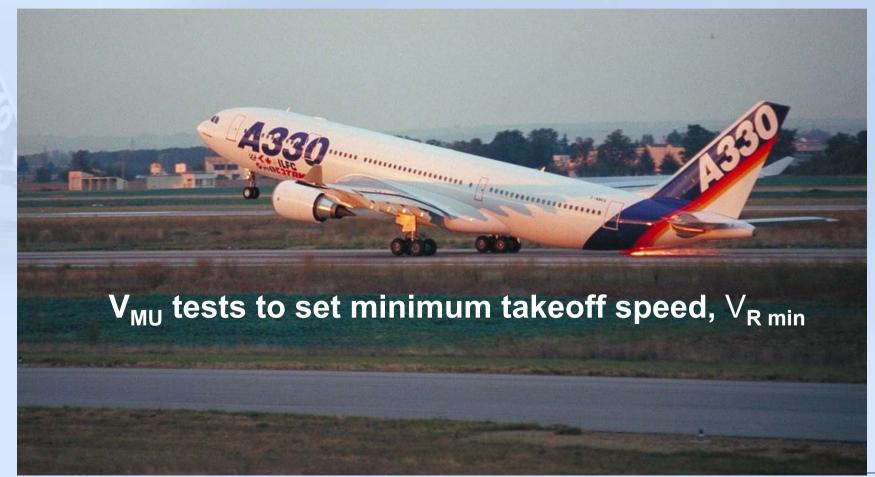
Factors affecting the margins (Takeoff)

•The rotation speed V_R : Margin increases with $V_R / V_{R \, min}$, and V_2 / V_S ratio

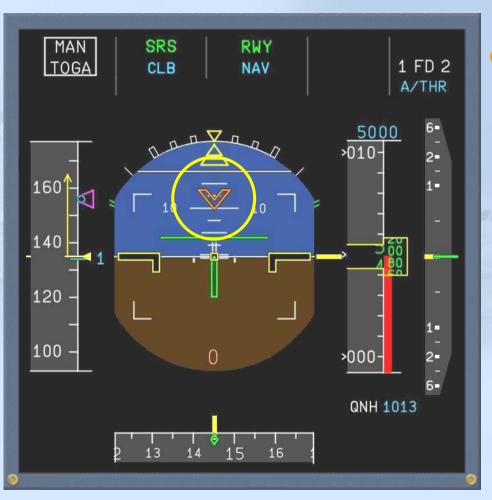
Aircraft design features

- Pitch limit indication is provided:
 - At take-off
 - From power application to3 sec after lift off
 - Maximum pitch altitude:
 optimized between 9°5 and
 14° (for A340-600)
 - At landing:
 - 8.4° below 400 feet /AGL.

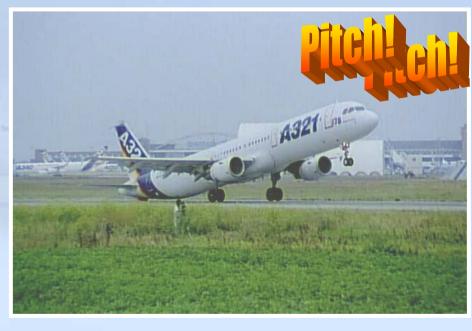
Reinforcement of PNF specific call outs for excessive pitch attitude on take off and landing
